## Municipal Separate Storm Sewer System (MS4) 2018 Annual Report

## **B.1.1 & B.2.1**

**MCM #2**  
**Rethink Runoff Stream Team**  
**2018 Summary of Activities**

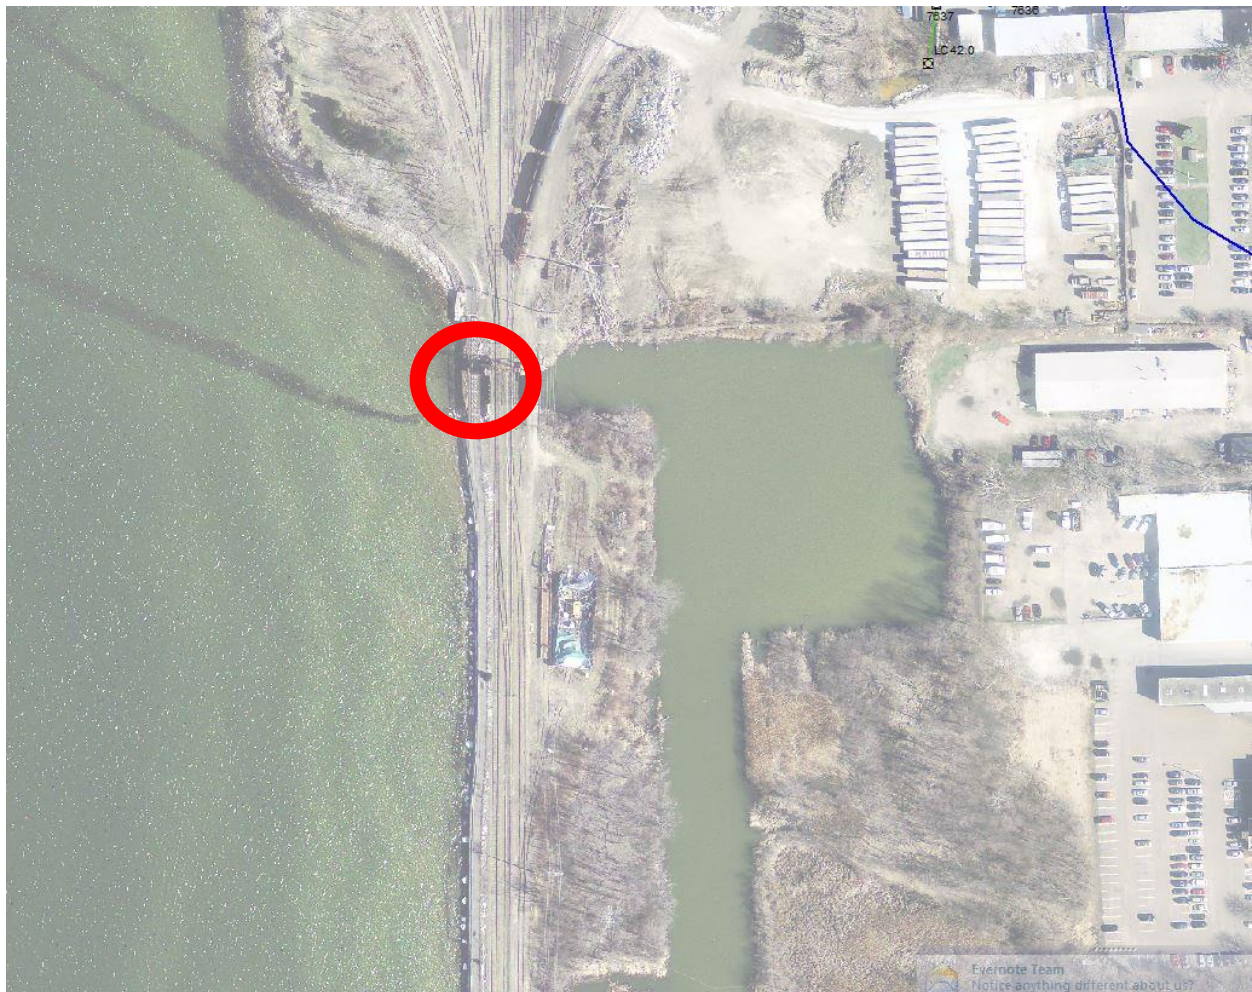
## **B-VT 1**

Pine Street Barge Canal – discharge from  
weir to Lake Champlain

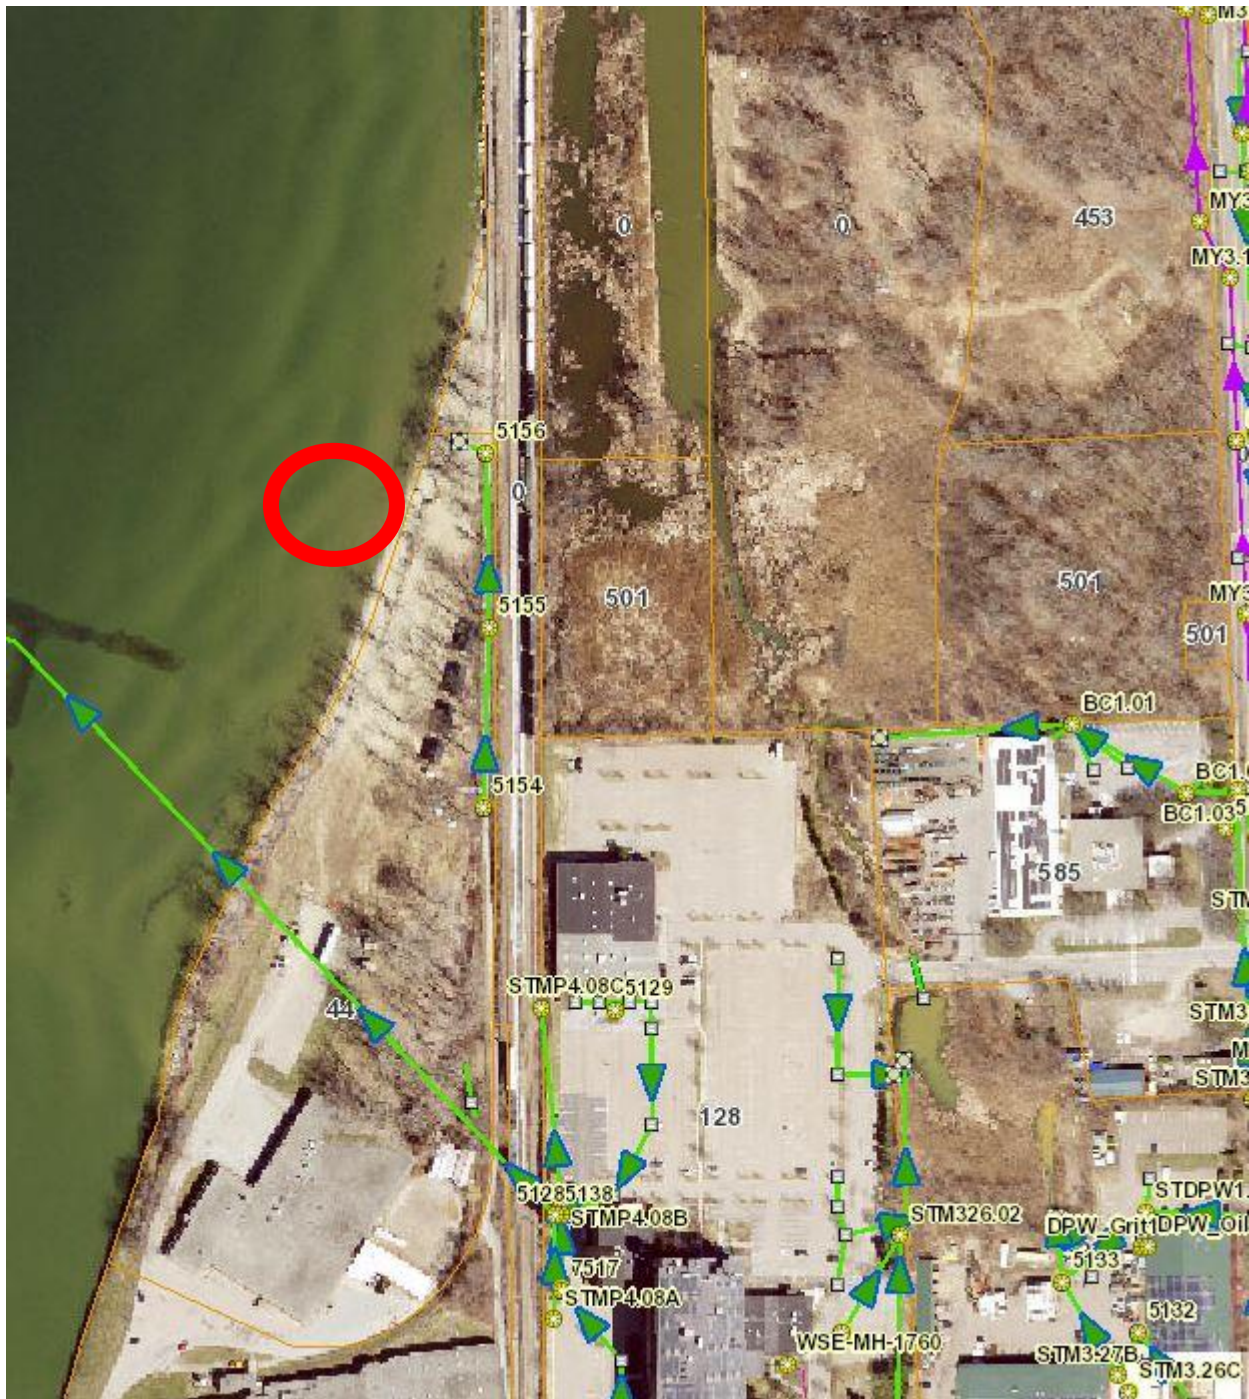
## B-VT 2

Blodgett Beach – in water

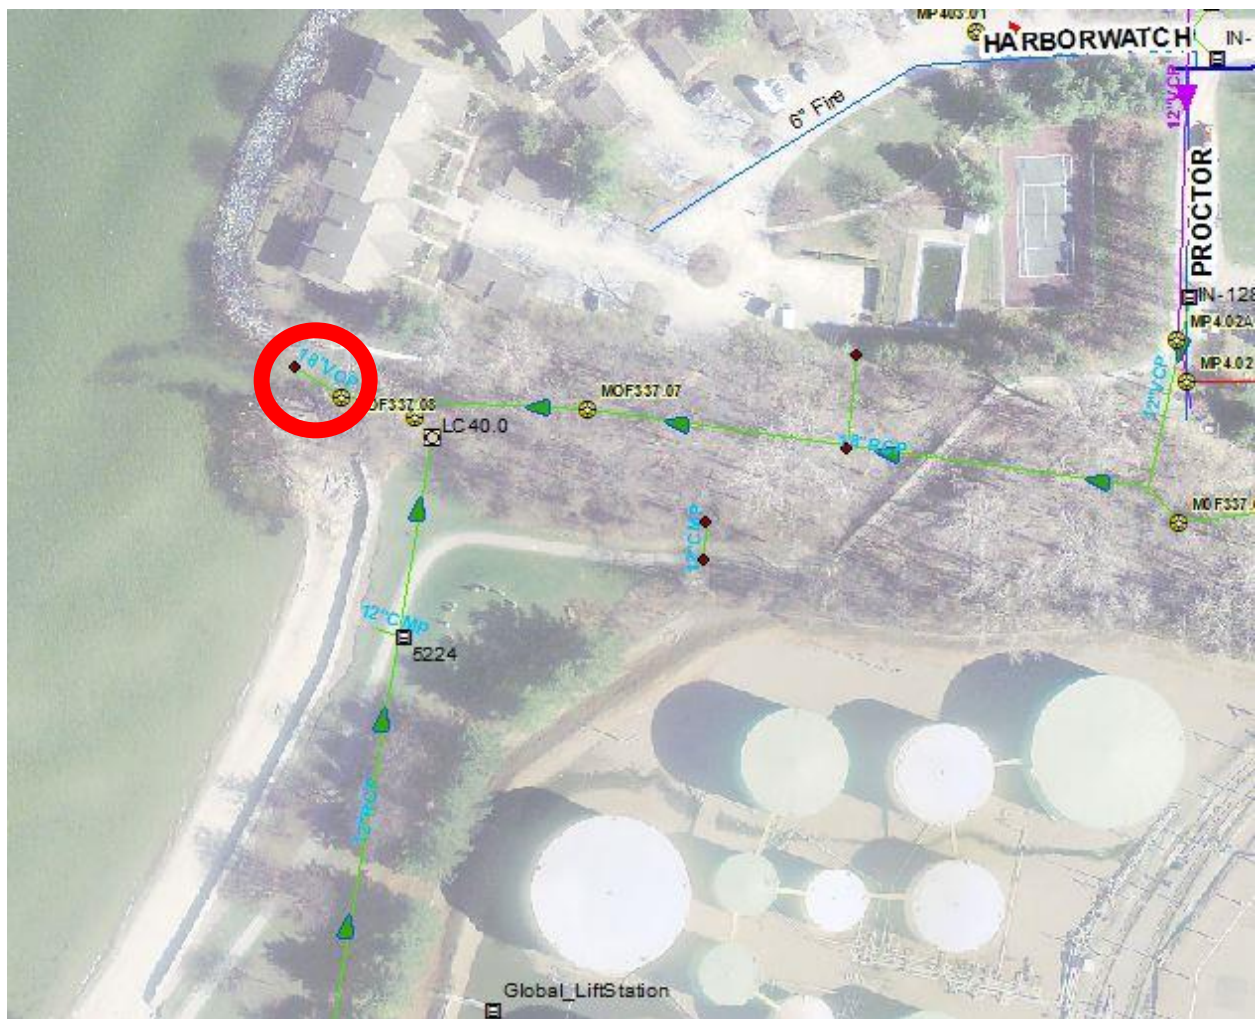
## B-VT 3

Englesby Brook @ confluence with  
Lake Champlain

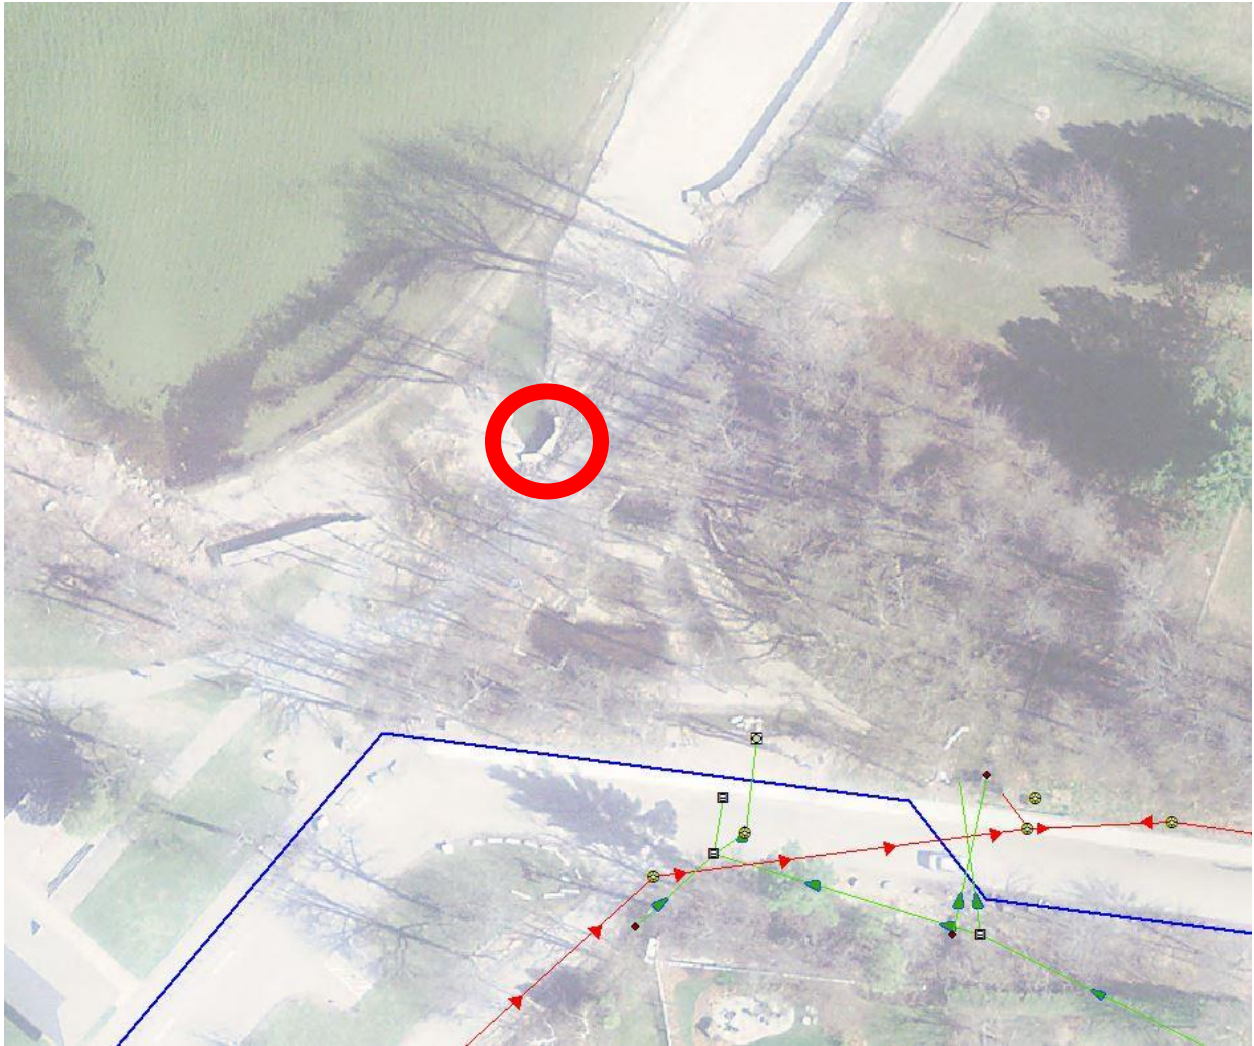
## B-VT 4

Oakledge Park – Blanchard Beach outfall
